## USS Yankee:

Recently EdgeTech had the opportunity to image the wreck with the new 4125 Side Scan Sonar System. Using the dual simultaneous frequency set of 600kHz / 1600kHz some remarkable acoustic images were generated. One can clearly see the intricate details of some of the remaining structures and features that still lie preserved 16 meters underwater.

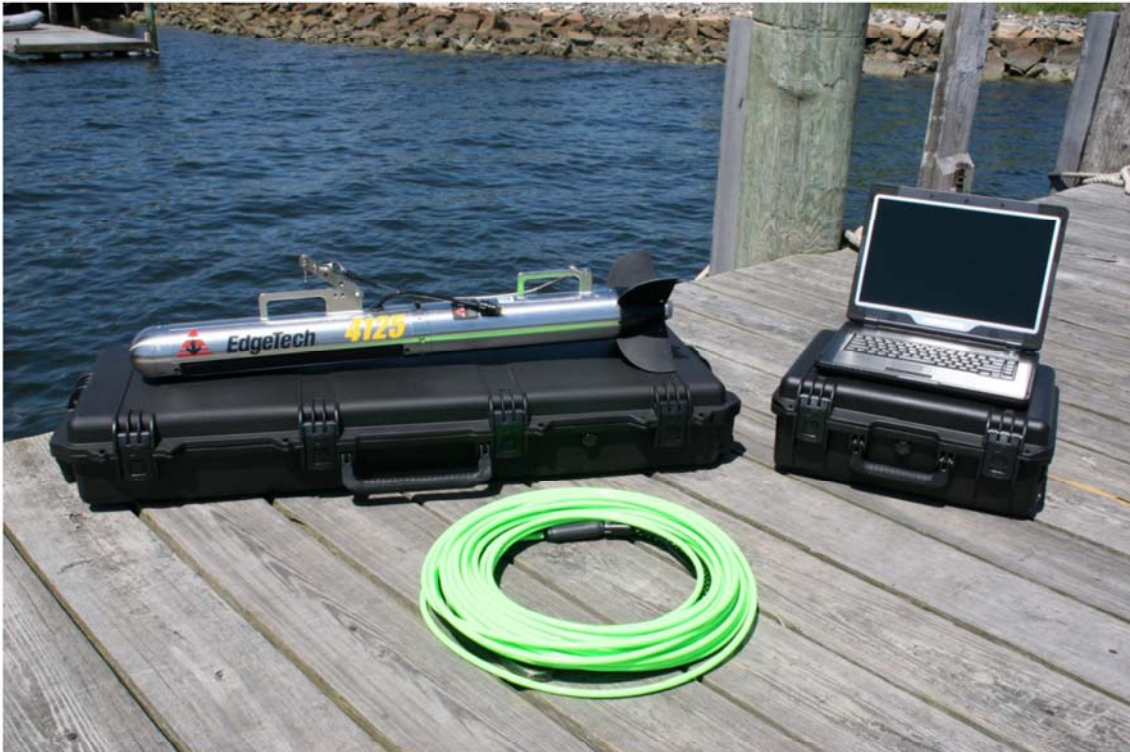
*EdgeTech 4125 Side Scan Sonar System*

Utilizing EdgeTech's Full Spectrum® CHIRP technology the system can generate images with centimeter level resolution in real-time. Easy to operate software makes the turnkey package a useful tool for anyone doing underwater exploration and research, from underwater archaeologist to emergency dive teams.

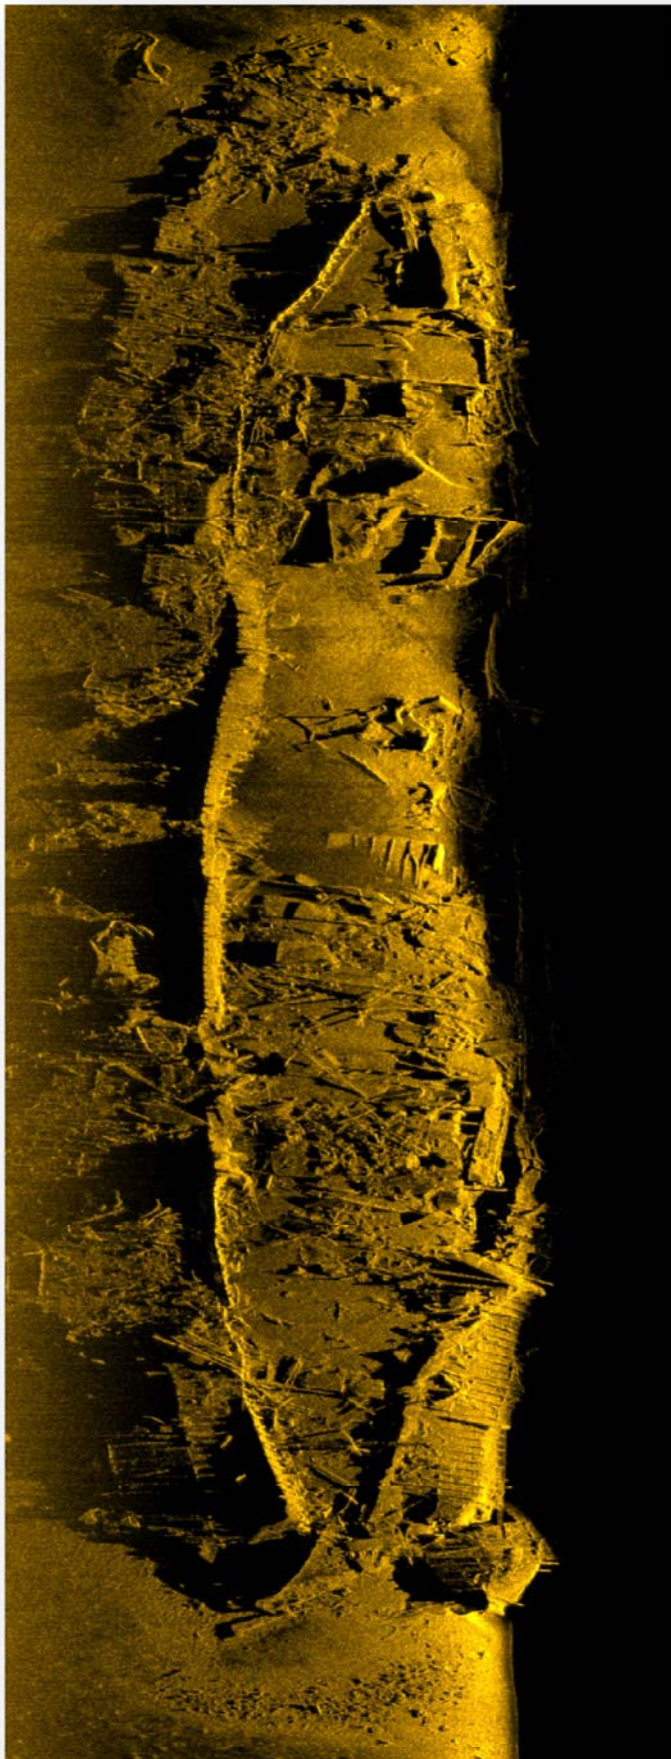
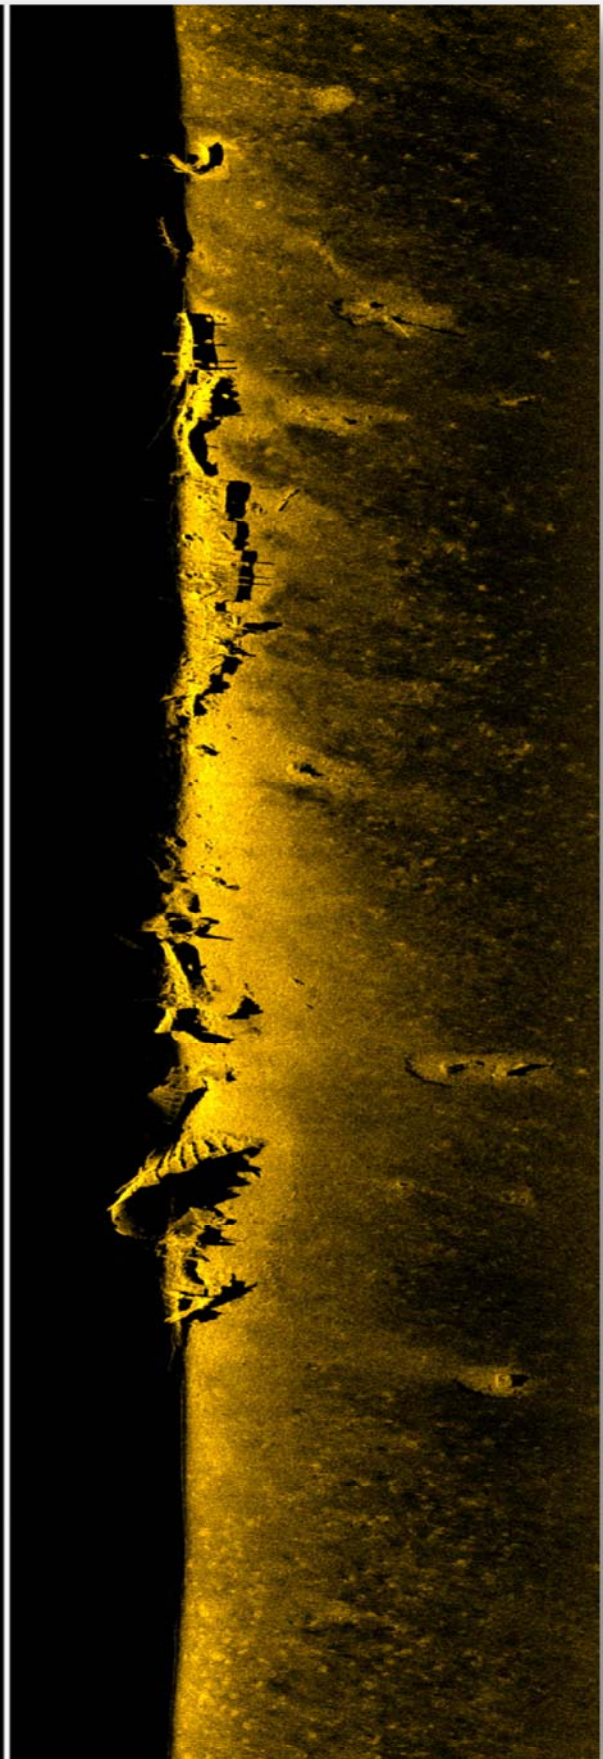
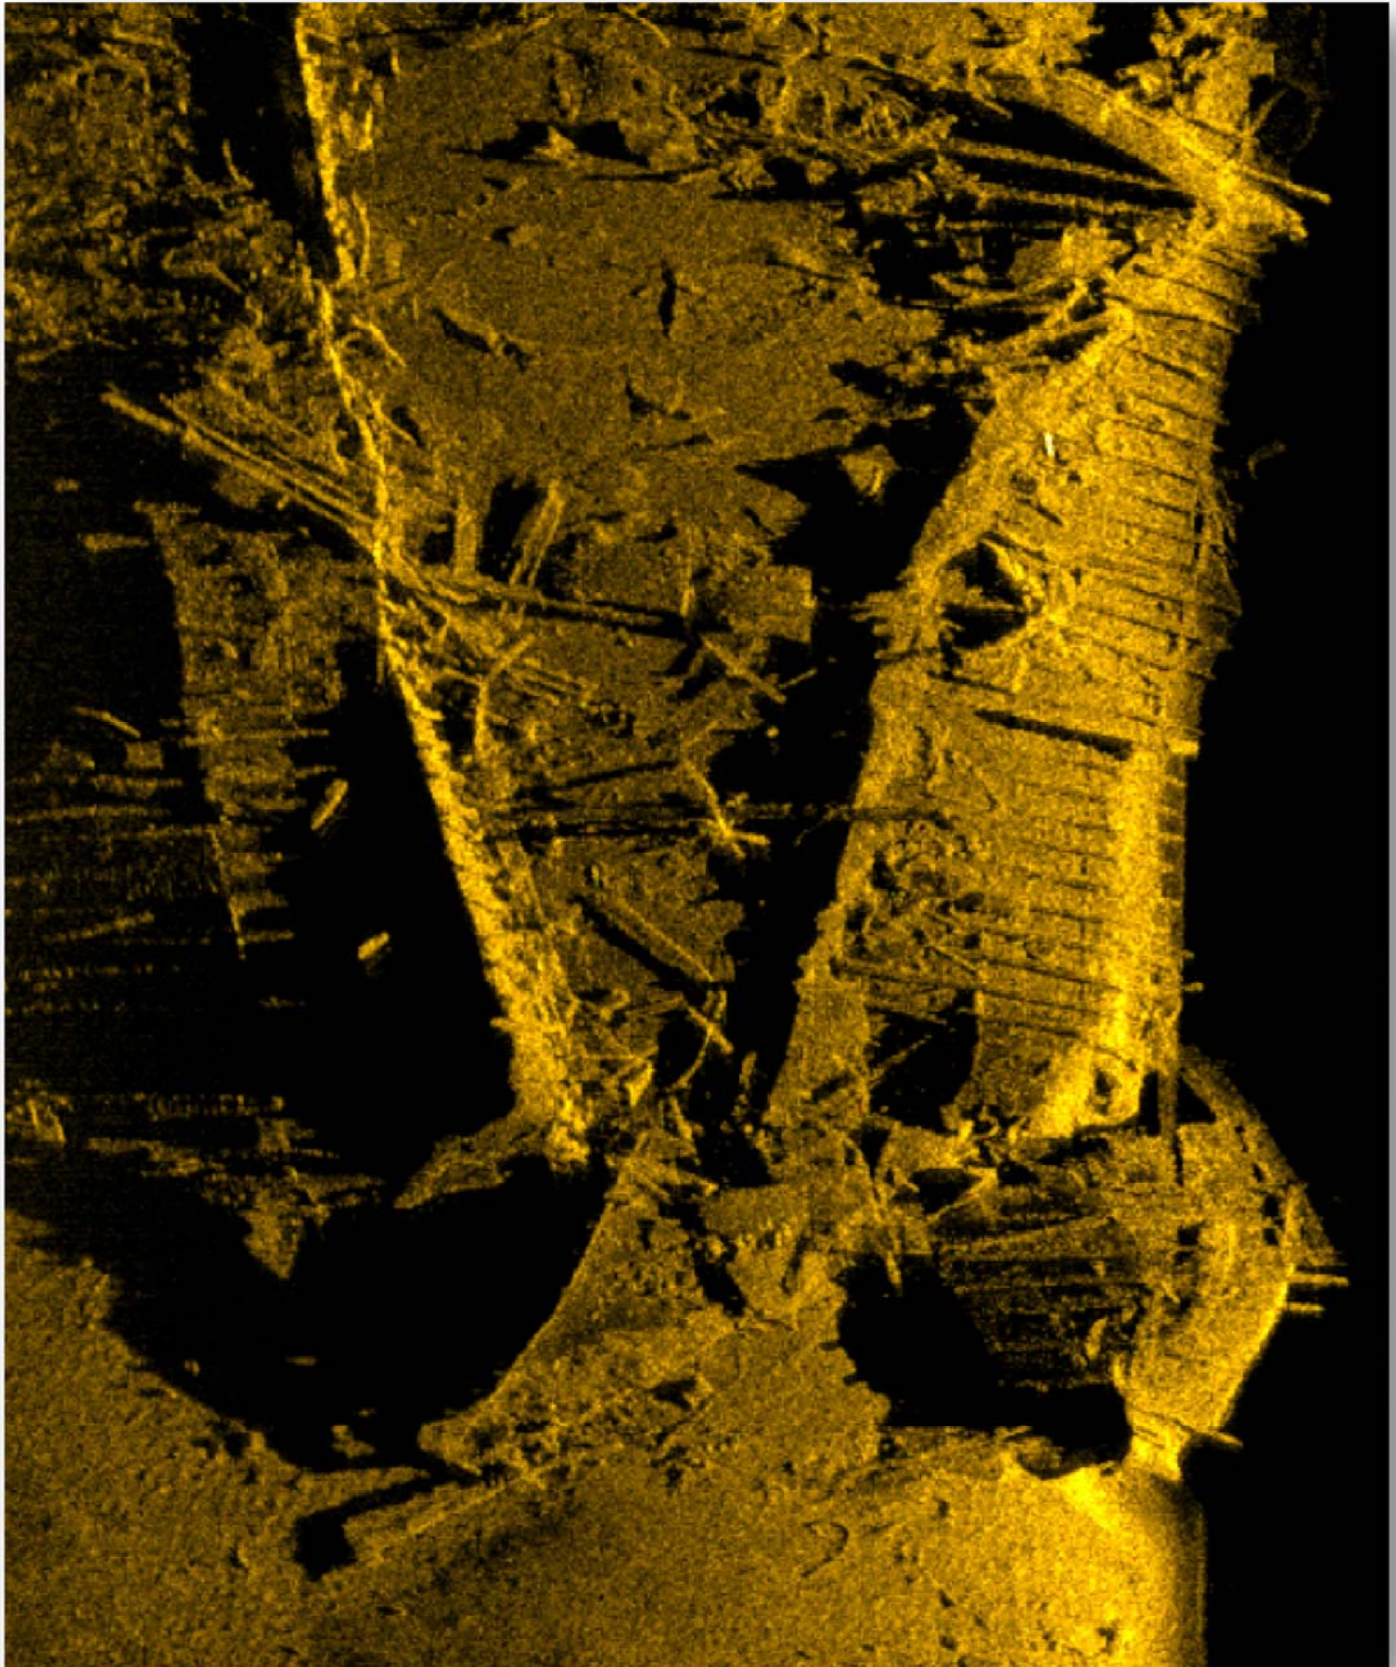
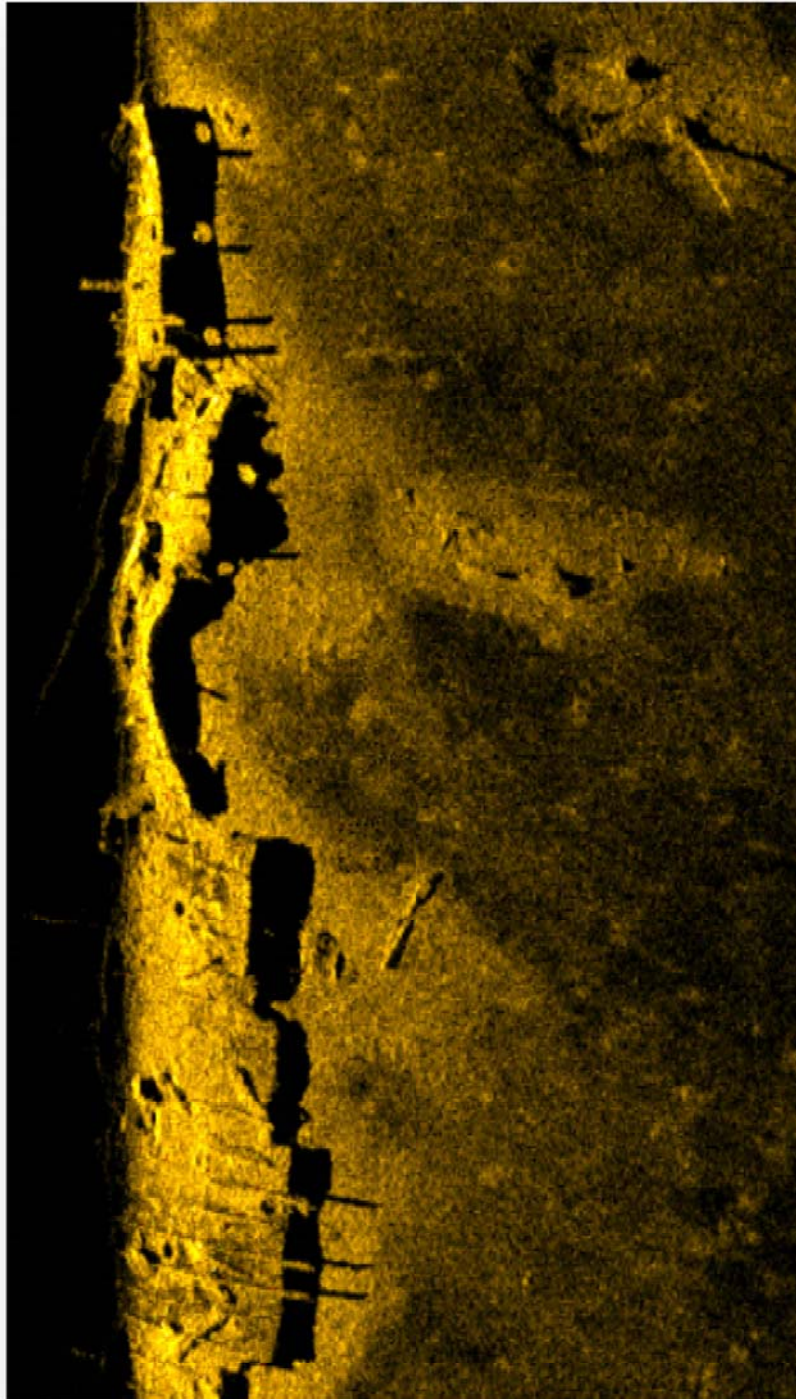
The pictures below are some samples of the amazing imagery captured with the ultra high resolution 1600 kHz frequency side scan. In the last image below, even the complete detail of the small circular holes, 1 foot (.3m) in diameter, left after the actual portholes were removed for preservation, can be easily identified near the seafloor.
