APPLICATION NOTE

LOCATING LOST UNDERWATER MOORINGS WITH HIGH RESOLUTION SIDE SCAN SONAR

Underwater search and relocation of lost mooring packages using a high resolution side scan sonar

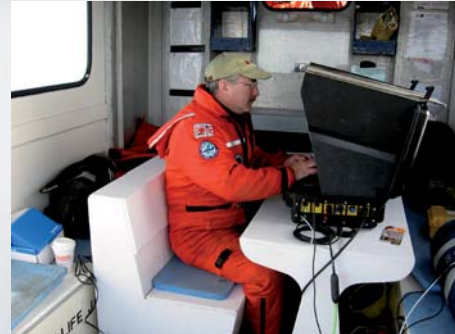
Operator views high resolution side scan sonar data in real time for quick identification of targets

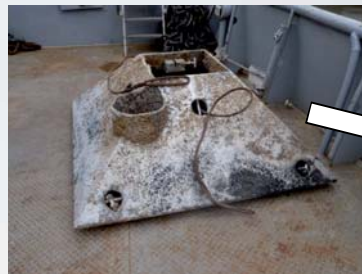
Another lost mooring located by the 4125 side scan sonar

Using the 4125, operator Rob Morris, was able to locate the lost underwater object within one hour of searching the suspected area. As seen in the images here the mooring was visible in the high resolution imagery and was easily identified.
